TNO report

2002-CVB-R06277

**Fire resistance of a Glaverbel glazed partition
construction following NEN 6069:1997 and NEN-
EN 1364-1**

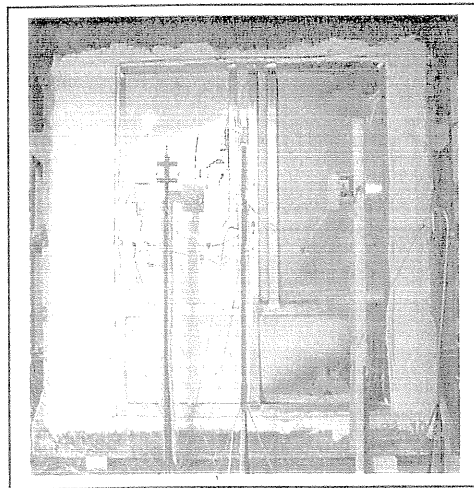
Picture 5. Left panes are opaque, right panes start to react, $t = 5$ mins.

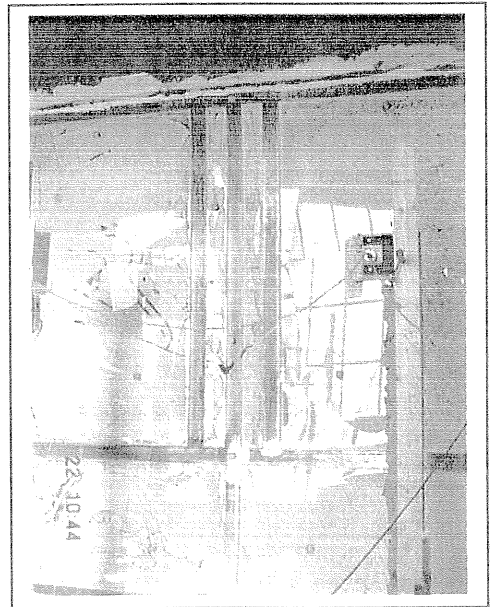
Picture 6. Steel frame discolours by heat, $t = 15$ mins.

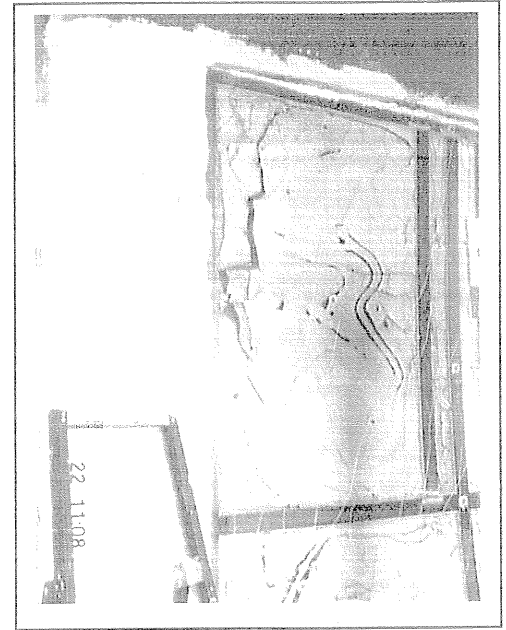
After heating for 37 minutes the furnace could be directly accessed through a crack on the top side of the large centre pane (**end of integrity criterion**).

Picture 8. The crack has grown; end of integrity, t = 39 mins.

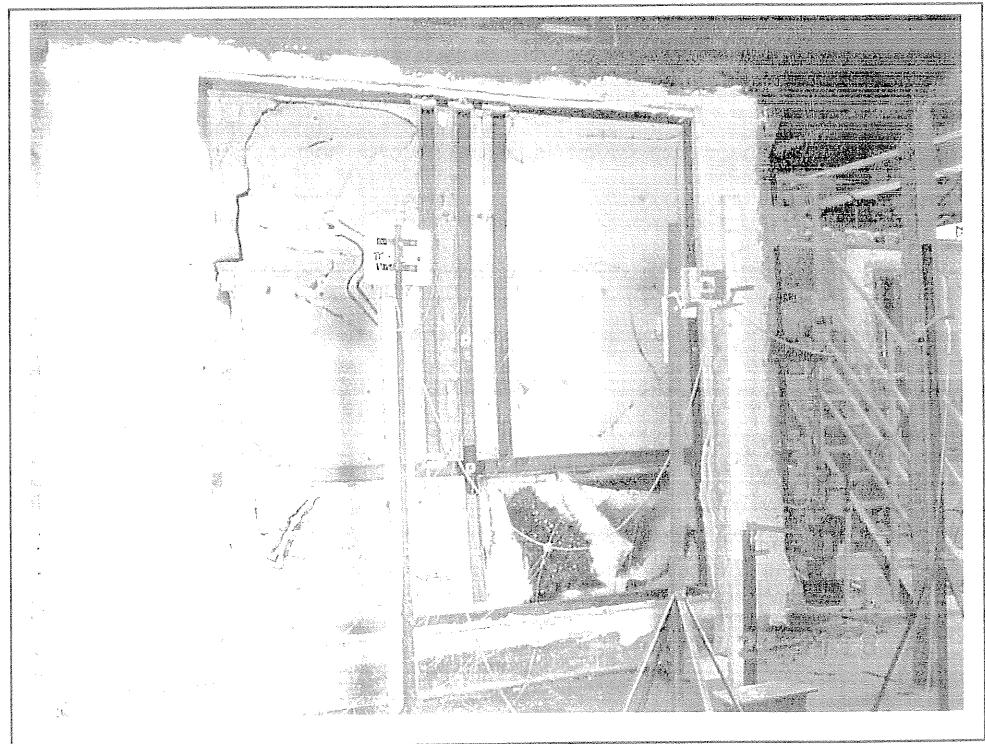
Picture 10. The specimen after the test.
