2007-Efectis-R0667[Rev.1]

Fire resistance of an aluminium curtain wall structure, type CW50-FP with glazing and panels, according to EN 1364-3: 2006, for the case "fire from outside to inside"

Reynaers Aluminium NV/SA

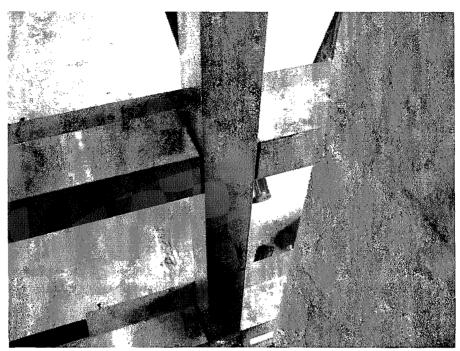
Photo 3: Junction of the structure.

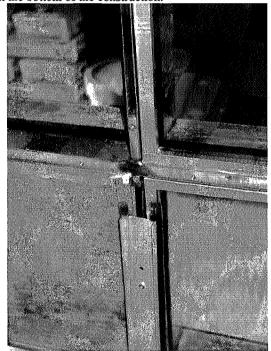
Photo 6: Glass support.

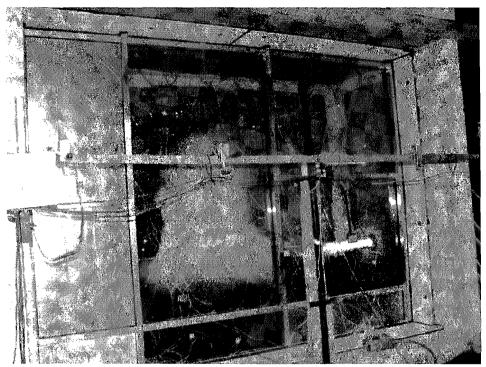
Photo 9: Foaming of pane A3.

Time [min]	Side	Observation
0		Start heating
45'	F	First cracks in glass A3
1	N	Cracks and breaking of glass A1 and A2
8	N	Foaming of glass pane A3
10	N	Smoke coming from the profiles at the top at pos. a, b and c
15		All panes almost completely foamed except the edges (photo 10)
21	F	Breaking of glass (audible) and deforming of profile at pos. d
23	N	All panes completely foamed
24	N	More smoke coming from the profiles at the top
30	N	Piece of glass falls from construction
40	N	Glass of pane A3 came partly forward
48	N	Several cones in glass at pos. e, f, g and h (photo12)
75	N	Temperature of thermocouple TC 37 more than 203°C: <i>Thermal insulation exceeded</i>
78	N	Temperature of thermocouples TC 35 and TC 38 more than 203°C
89	N	Temperature of thermocouple TC 25 more than 203°C
90	N	Temperature of thermocouples TC 13 and TC 14 average temperature more than 164 °C
91	N	End of heating

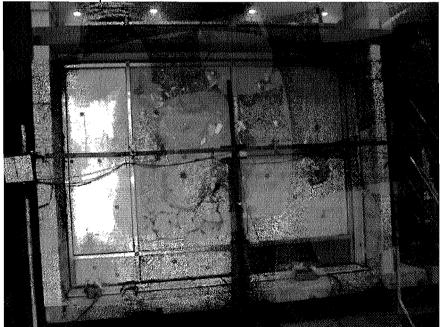
Photo 12: Curtain wall structure after the test.
